Terra Vigilis Environmental Services Group

Water Quality and Wave Impact Study
Phase 2 Report

Prepared for the North Lake Management District

July 20, 2022

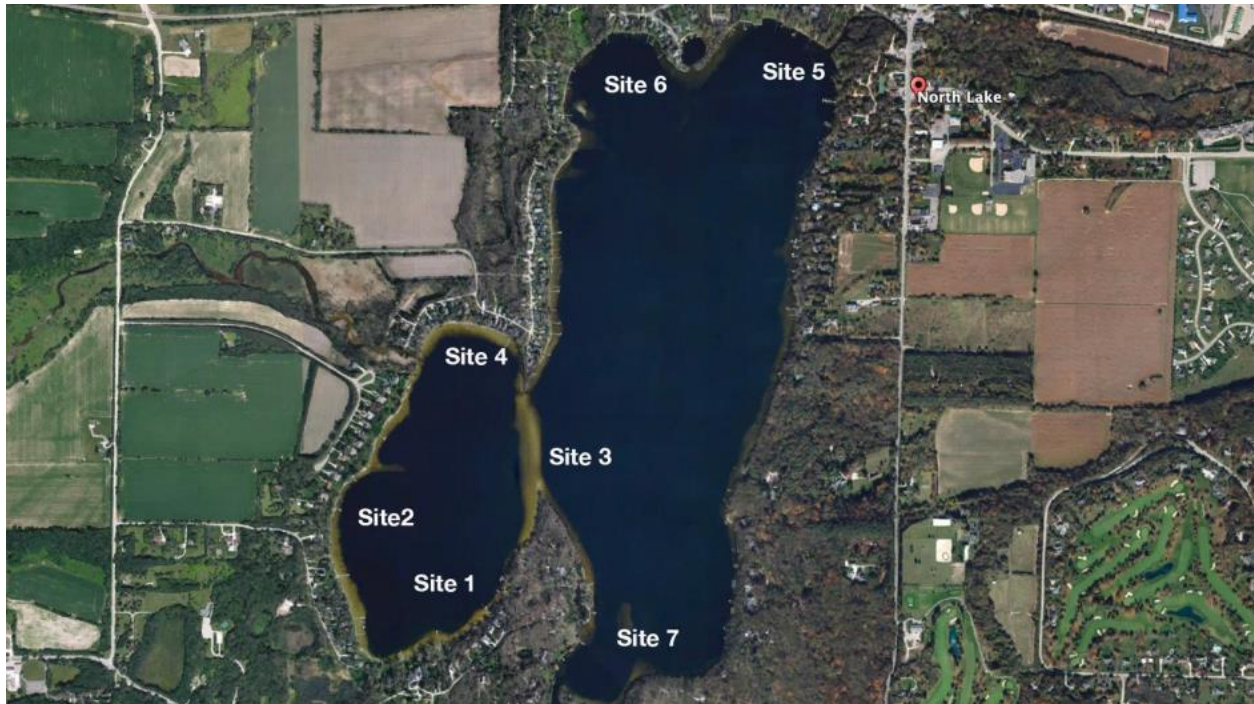
Figure 1: Sample Sites

Some water chemistry sampling was conducted during 10 weeks at seven sites on North Lake. See Figure 1. The sites included river inlets at both the North and South ends of the “Big Lake” (large and small Oconomowoc rivers, Mason Creek, and the inlet from Cornell Lake). Additional testing sites in the small lake basin have also been sampled. Water depths at the seven sites are as follows:

<u>Site #</u>	<u>Water depth</u>
1	25'
2	23'
3	26'
4	21'
5	17'
6	20'
7	22'

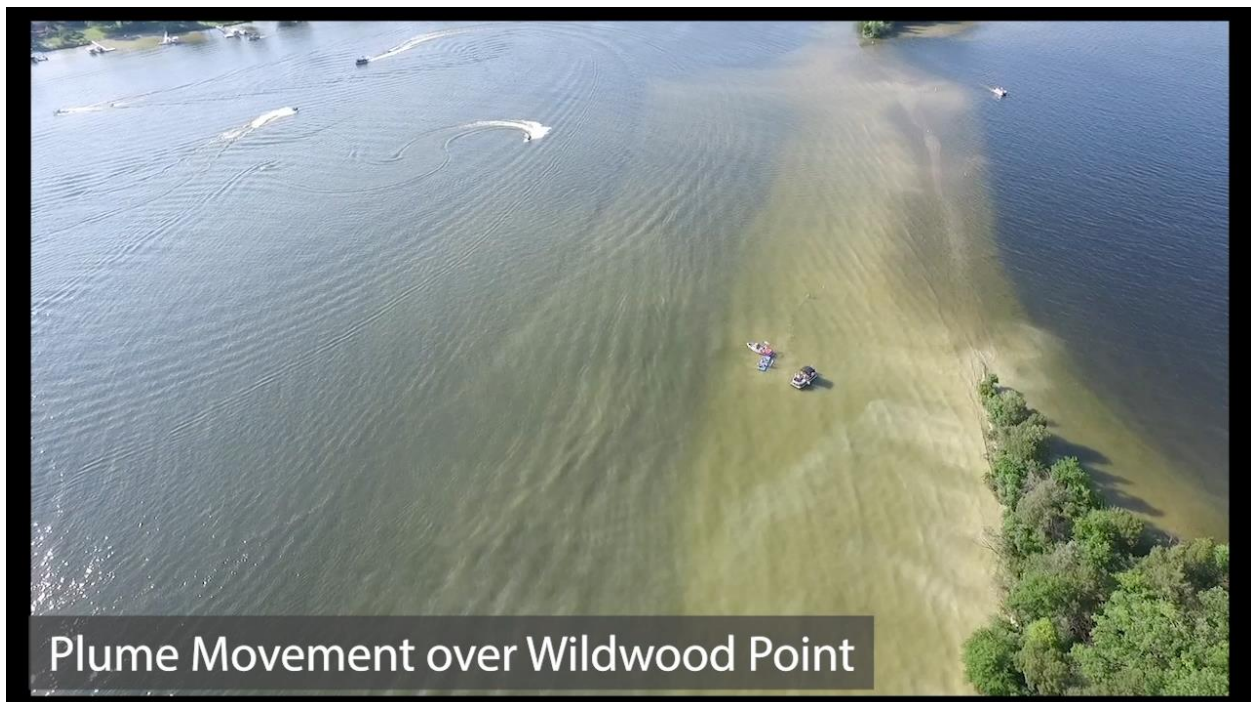
Figure 2-Video: Sediment Redistribution

Aerial imagery from a drone survey shows how general boating conditions on the Small Basin of North Lake can create significant resuspension of nearshore substrates at Wildwood Point, which can at times travel across the point and into the Large Basin of North Lake. It is not possible to separate the impacts from any one type of boat in this footage, but it does indicate that recreational boating can impact the nearshore resuspension of sediments in the Little Basin of North Lake. This is consistent with results of the wave measurement comparison analysis in Domain 5 below. (See Figure 2-Video).

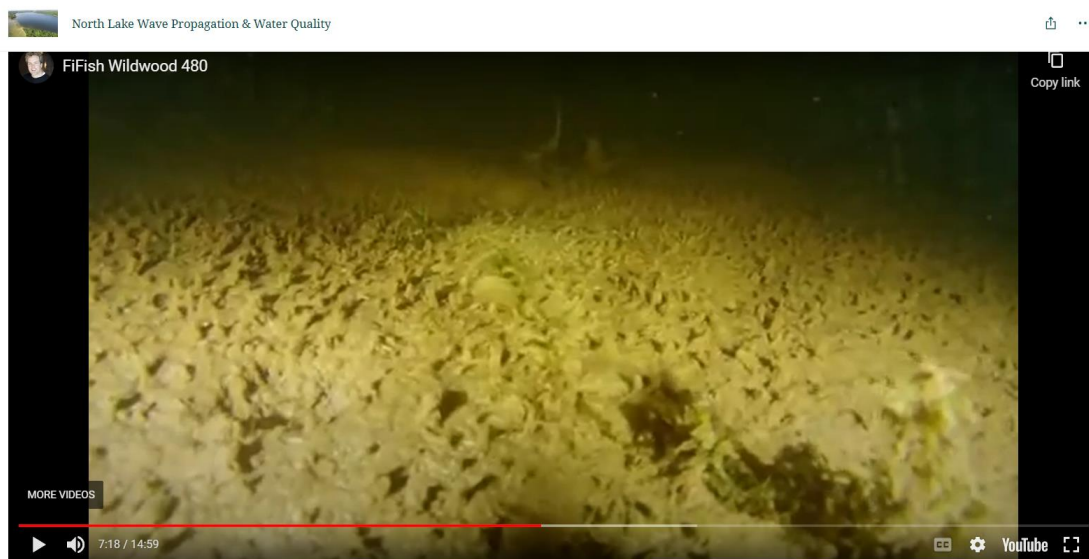
Figure 3 Video - Fall 2020 Wildwood Point Reef

The Figure 3 video seems to show or suggest that there may be some deposition of sediments on top of what appear to be plants in these deeper waters (i.e., 10 to 15 feet), however this was not verified. If such sediments were depositing within these areas, it could potentially be inhibiting growth of plants in North Lake in depths greater than 10 to 15 feet. However, given that almost no plants are found in either basin in depths greater than 10 to 15 feet since at least year 2012, inhibition of plant growth due to sedimentation redistribution has not been verified. Nonetheless, if it could be verified that boat generated waves were contributing to increased sediment deposition in these nearshore areas, this would be an important finding to the overall health of the Lake.

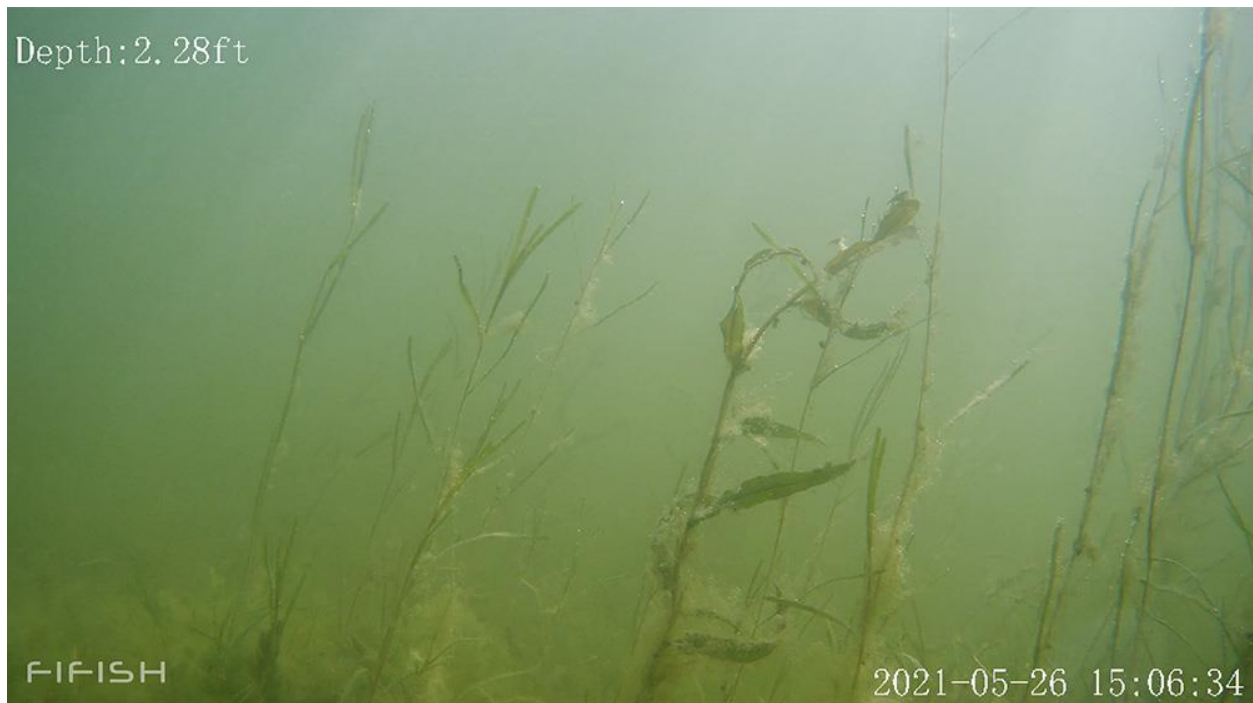
[Figure 4-Video Wildwood Point reef - Spring 2021](#)

Results from the underwater aquatic plant and lake bottom videography survey revealed the healthy presence of several native species (e.g., Flat-stem pondweed, Fries Pondweed, and Vallisneria) and one exotic invasive species (i.e., Eurasian Watermilfoil) of aquatic submergent plants. The submersible verified that there was moderately abundant plant growth observed in water depths less than or equal to 10 feet and that there are essentially no or very limited plants in waters greater than 10 feet and not plants deeper than 15 feet in depth (see Figure 3 Video). This is likely due to light limitations, and previous aquatic plant surveys in the large basin support this finding. In years 2012 and 2018 aquatic plant surveys indicate that 93 percent and 95 percent of the plant community were observed in depths less than or equal to 10 feet, respectively. Hence, only about 5 to less than 10 percent of the remaining aquatic plant community was observed in depths from 10 to 15 feet, and no plants in water depths greater than 15 feet. This is consistent with what was observed in Figure 4 video showing abundant plants at 2.28 feet and Figure 5 video showing no plants at 13.56 feet.

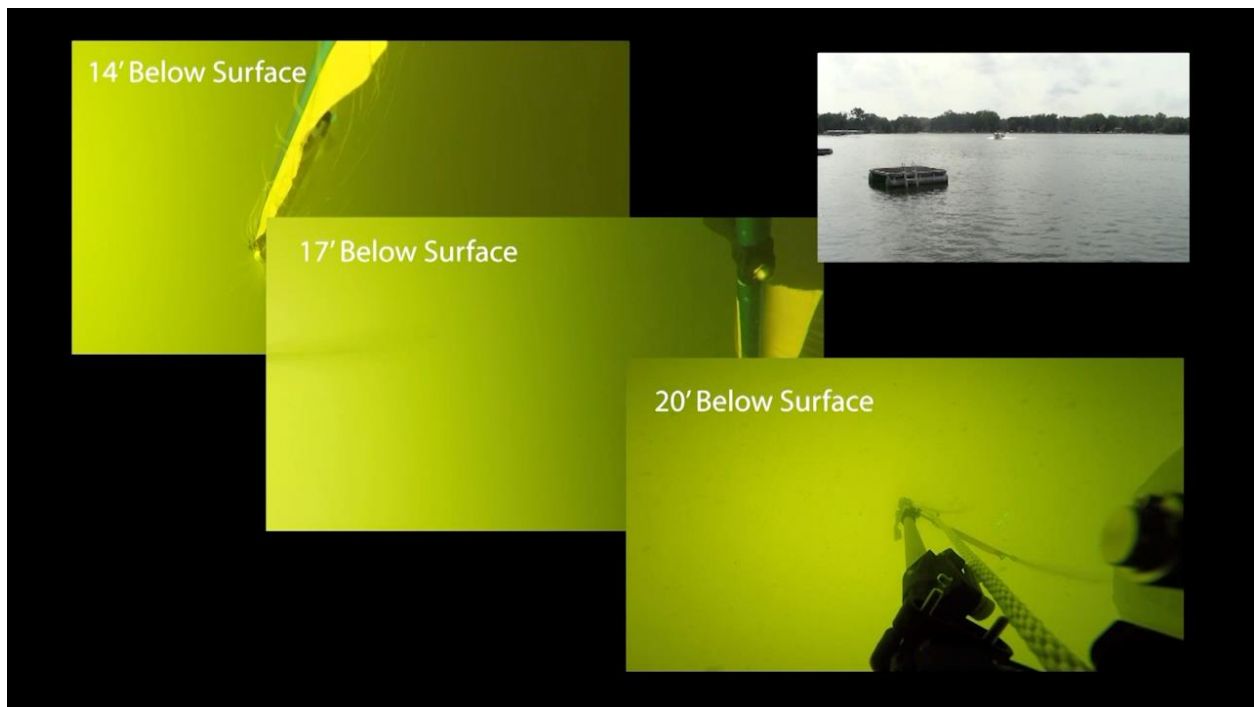
The Phase 2 study included measurement of propeller downwash dynamics for selected vessels in use on North Lake. Measurements included a combination of underwater photography and videography imagery of fibre optics responding to propeller downwash energy and water movement as deep as 20 plus feet. See Figure 7-Video.

All boats produce a subsurface propwash, but wakeboard boats in surf mode produce propwash depths nearly 3-4 times greater than the other vessels, which is due to differences in propeller angles, ballasting and larger engine output. Data gathered on July 2, 2021 demonstrated that prop downwash depths of no more than 3-5' were observed for Pontoon boat, ski boat, and PWC while planing.

[Figure 7-Video](#): Camera views at staggered depths showing fibre optic responses to Wakeboard boats in surf mode.

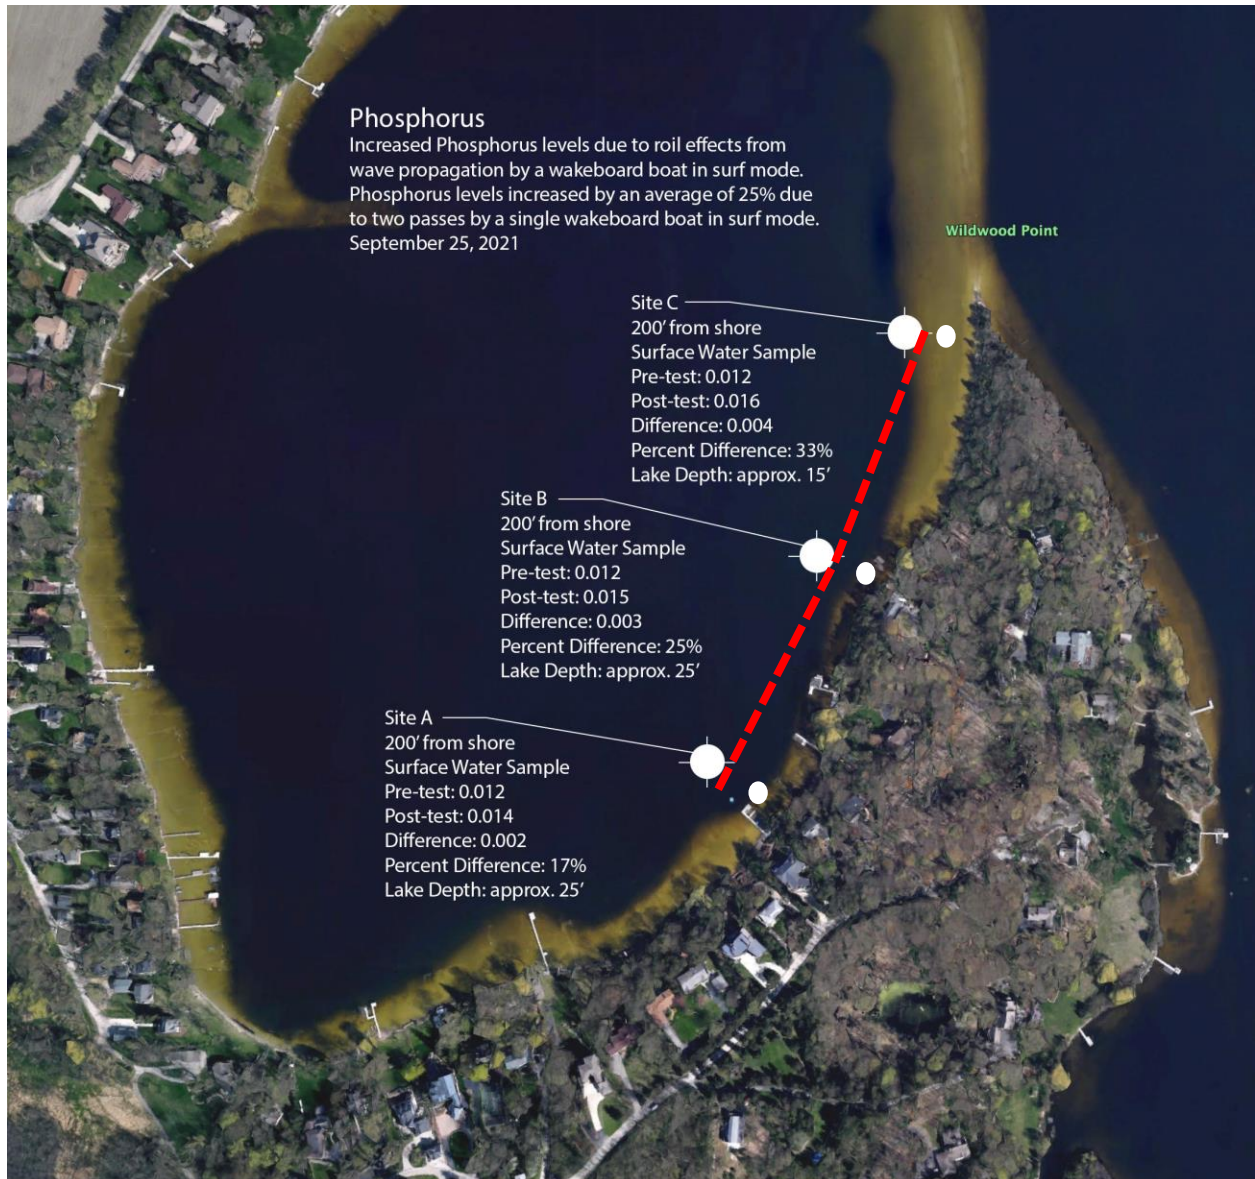
On September 25, 2021 a test was performed to measure phosphorous release by roil effect (i.e. creating water turbidity by disturbing the sediment) from wave propagation produced by surf mode operations on a standard course length of approximately 800 yards along a buoy course 200' from the shoreline (See Figure 18).

Measurements of Phosphorous before and after the disturbance of sediments due to wakeboard boat downwash effects was accomplished by collecting water samples 6" below the water surface 100' from the shoreline where the water depth was 3-5' deep. A total of 2 course runs (North and South) were made at standard surf mode features (full ballasting, raised bow angle and approximately 10 mph of operating speed). Calm water conditions were present. The water depths along this course were determined by doppler study and ranged from 25 feet of depth at the southern end of the course and 15 feet at the northern end of the course. The data gathered (following laboratory analyses) showed a range of phosphorous increases in the water column along this course (3 sites sampled) from 17% to 33 % increase within 30 minutes of initial disturbance. See Table 1.

Figure 18: Course and Sampling Sites for Nutrient Load Differences (pre-post) from Wakeboard Boat in Surf Mode
